Thermal imaging cameras monitor overhead lines in Delhi metro railways

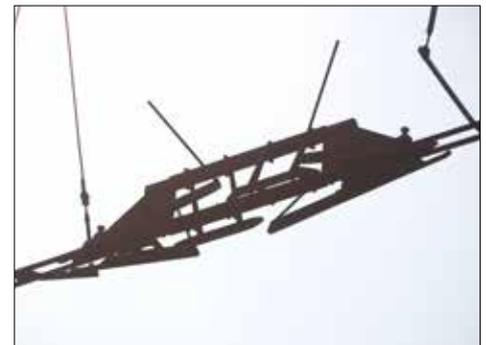
Early detection of rises in temperature helps DMRC to prevent costly failures and downtime.

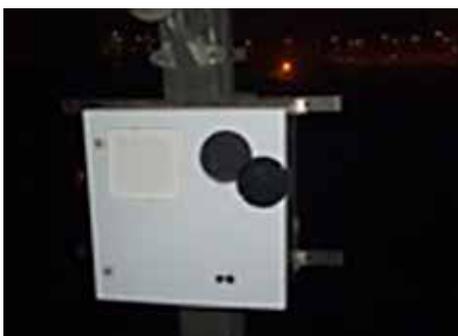
The FLIR E50 thermal imaging camera is installed in an IP66 rated enclosure.

When recently problems occurred in the metro railway network, which caused huge delays, DMRC suspected the problem was caused by the section insulators. The DMRC maintenance crew therefore installed one of their FLIR E50 thermal imaging cameras in an IP66 rated protective enclosure with Germanium infrared window to monitor the problematic section for an entire work day. Protected from adverse weather conditions by the protective enclosure the FLIR E50 thermal imaging camera was able to safely record the infrared radiation emitted by the section insulators and provide thermal
